State of California The Resources Agency DEPARTMENT OF WATER RESOURCES

SEPTEMBER 2002 OFFICE REPORT

THE INSPECTION OF FLOOD CONTROL PROJECT CHANNELS ON THE SACRAMENTO AND SAN JOAQUIN RIVERS AND THEIR TRIBUTARIES AND THE TRUCKEE RIVER

Prepared By The Flood Operations Branch Flood Project Inspection Section

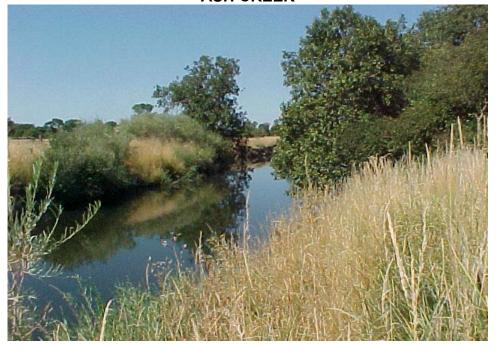
Downstream from Ash Street, moderate tree growth and bank erosion.

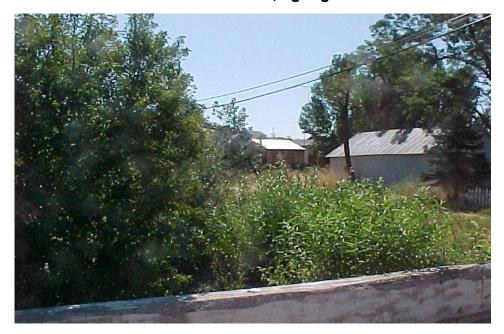
Upstream from Main Street (Hwy. 299) moderate growth in channel.

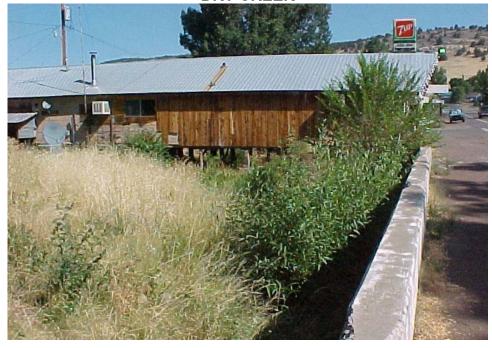
Downstream from Main Street (Highway 299), moderate growth in channel.

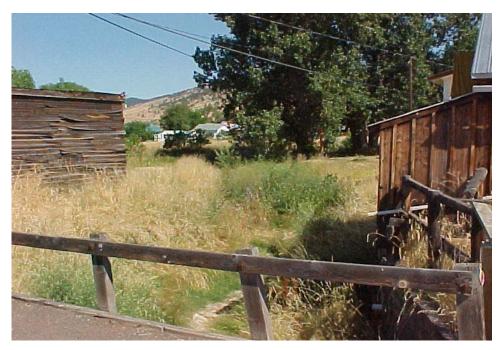
Downstream from McDowell Street towards Ash Creek, light growth.

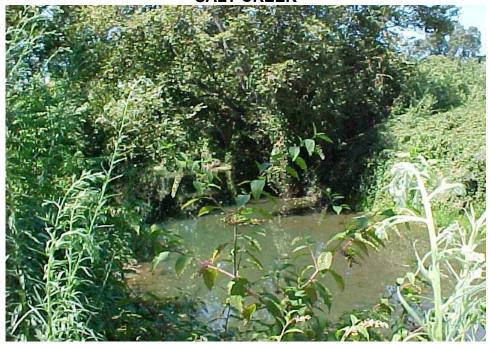
Approximately 700 feet upstream of the downstream limit.

Dense vegetation along both banks.

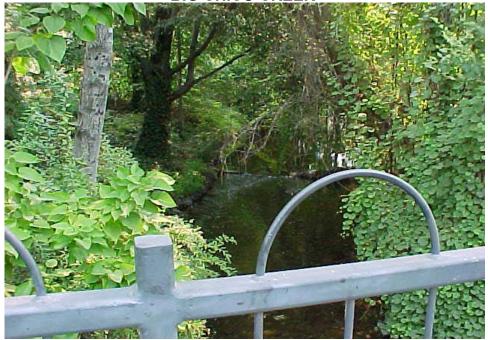
Upstream from the Esplanade. Heavy growth on both banks.

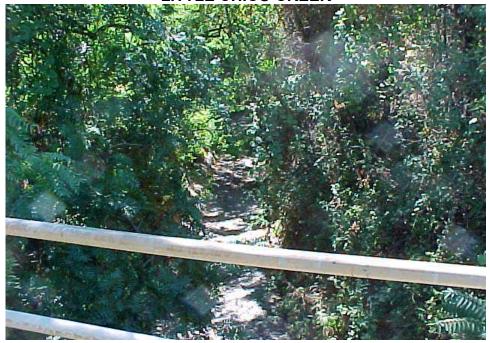
Upstream from Lone Pine Street. Dense vegetation on both banks.

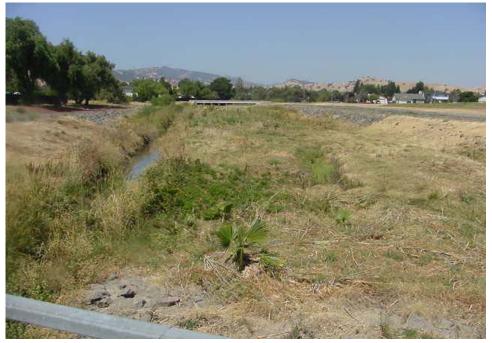
Upstream from Cement Hill Road towards Gulf Drive.

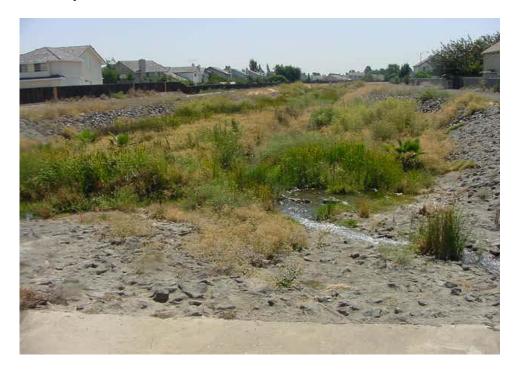
Downstream from Cement Hill Road.

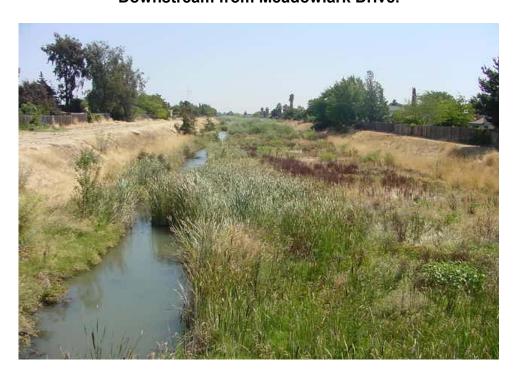
Downstream from Blossom Road.

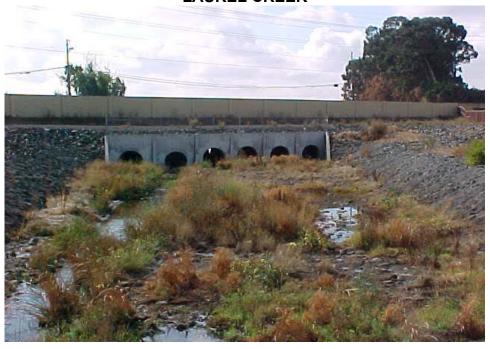
Downstream from Matthew Road towards railroad culvert under crossing

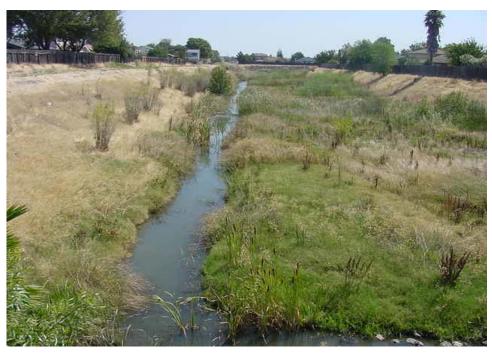
LAUREL CREEK Downstream from Worley Road towards the confluence with McCoy Creek.

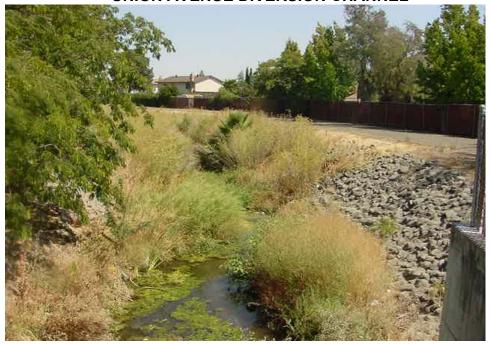
Downstream from North Texas Street.

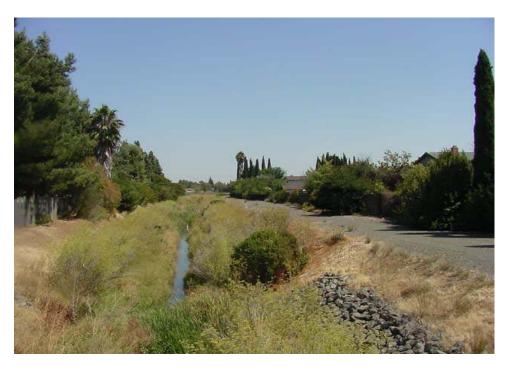
Downstream from Camrose Avenue.

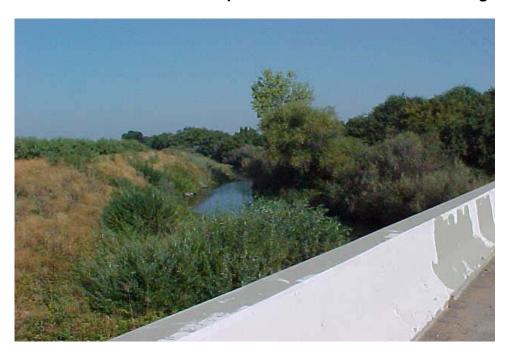
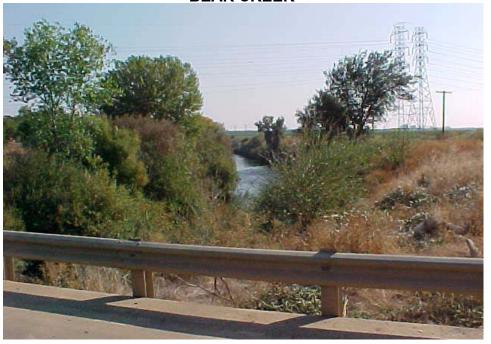
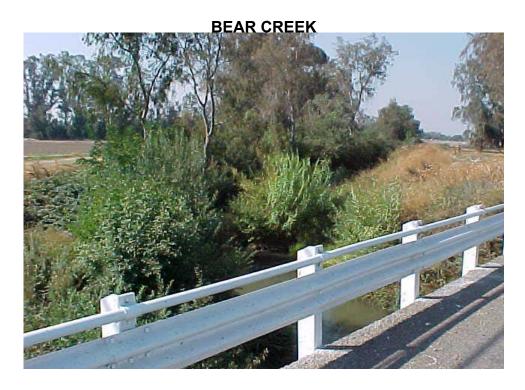
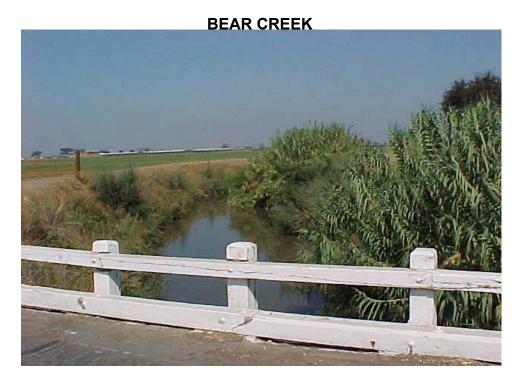
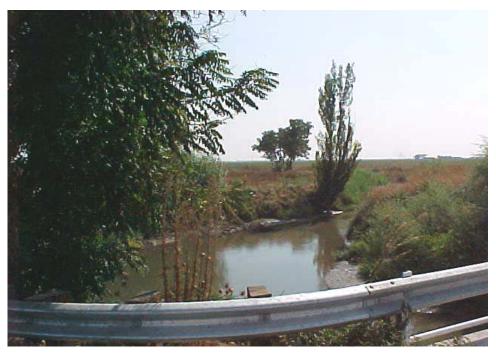
In September 2002, an inspection was made of Bear Creek. The project channel begins 2.0 miles upstream of the confluence with Burns Creek and extends downstream 21.0 miles to Bert Crane Road. Only 15 miles could be inspected due to limited access. The views of the channel are primarily at road crossings. The photos on the following pages are typical of, but do not show, all the growth in the channel. Moderate to heavy growth exists along both banks from the confluence with Burns Creek to approximately the Merced City limits. From Franklin Road to Dickerson Ferry Road, the channel and banks are overgrown to the extent that moderate flows could be adversely affected causing bank overflow. A clearing program should be implemented immediately.

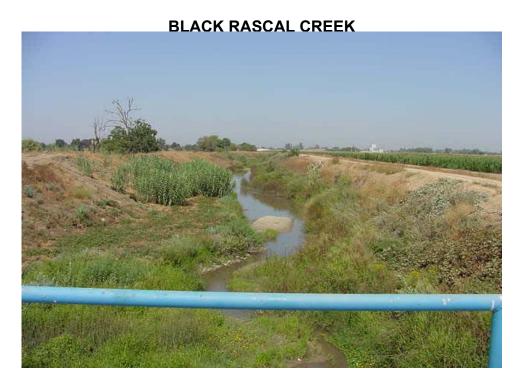
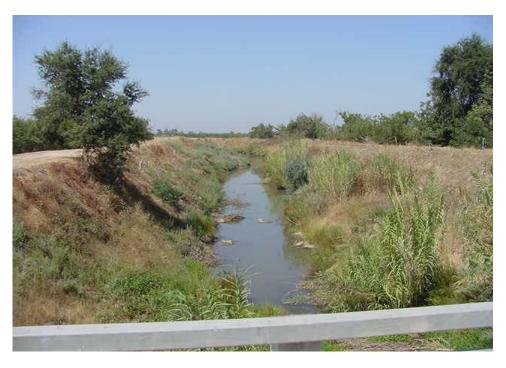
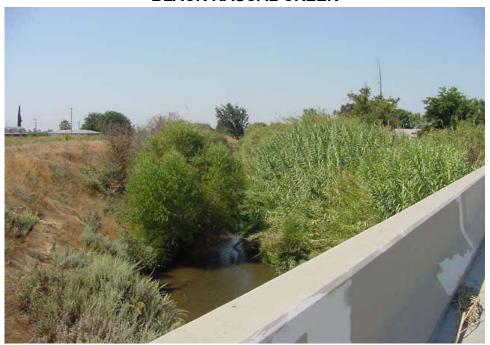
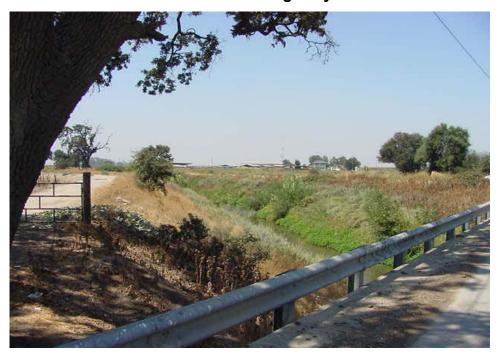
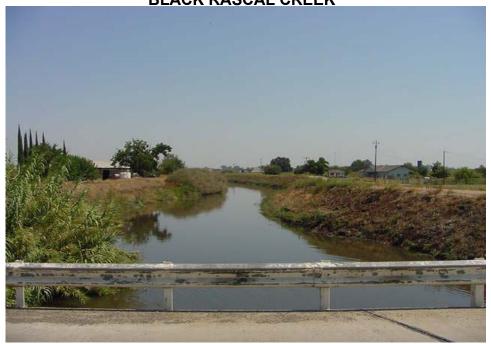
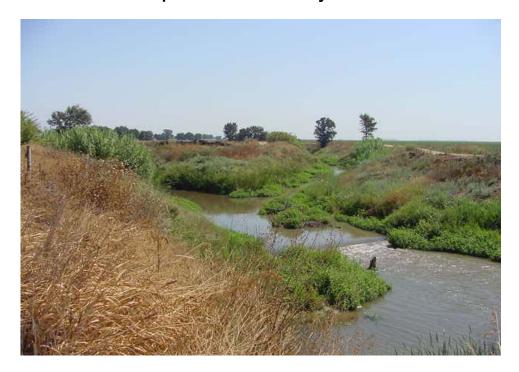
In September 2002, an inspection was made of Black Rascal Creek Channel. The project channel begins at Crocker Dam and extends downstream 6.5 miles to Black Rascal Creek's confluence with Bear Creek. The entire 6.5 miles were inspected. Views of the channel are primarily at road crossings. The photos on the following pages are typical of, but do not show all the growth in the channel. The wild growth should be cleared to allow proper design flow.

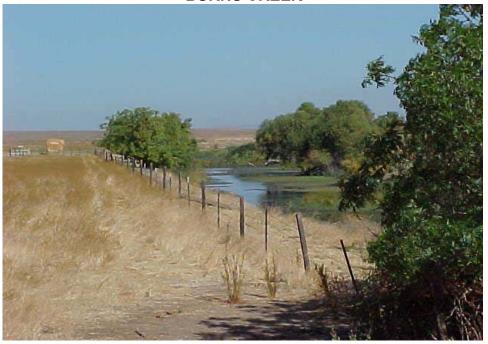
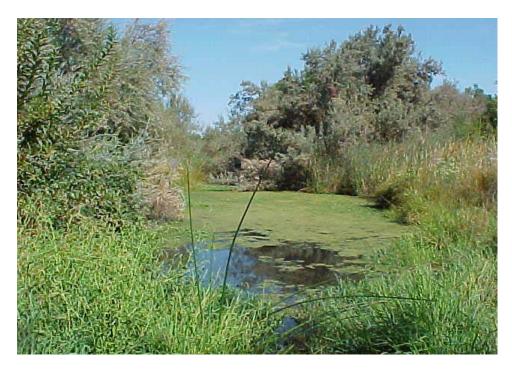
The project channel begins 2.0 miles upstream of Burns Creek's confluence with Bear Creek and extends 2.0 miles downstream to the confluence. Only 1.0 mile of channel could be inspected due to inaccessibility. The photos on the following pages are typical of, but do not show all the growth in the channel. Channel appears to meet design flow capacity.

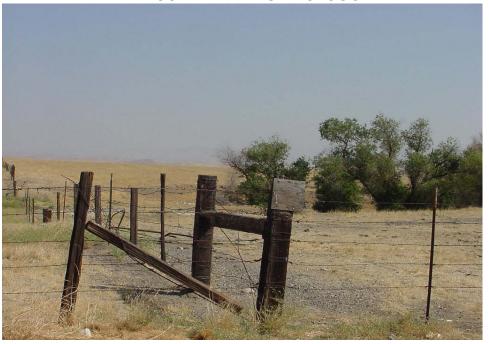
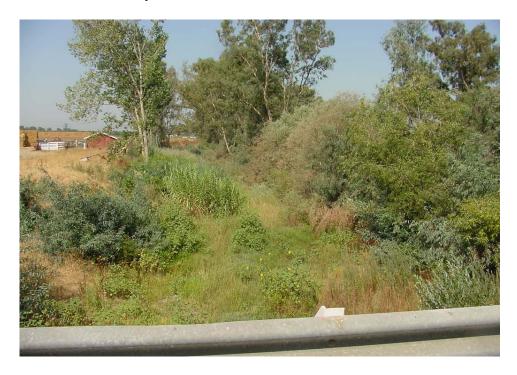
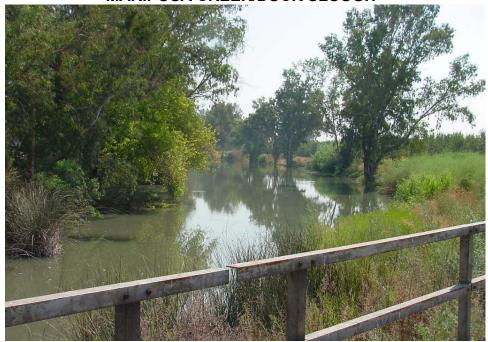
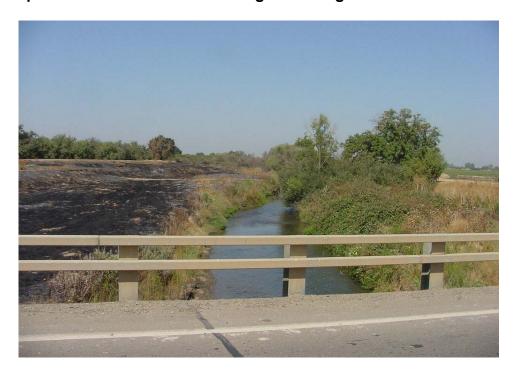
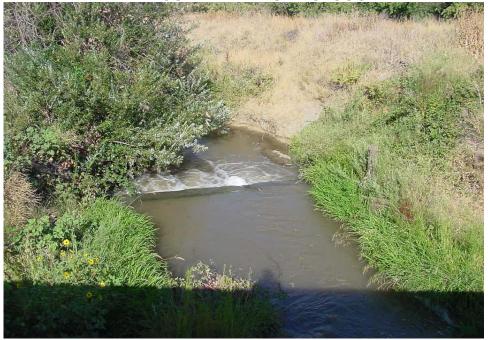
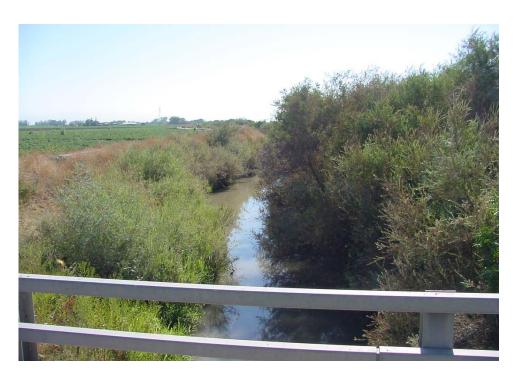
In September 2002, an inspection was made of Mariposa Creek/Duck Slough channel. The project channel begins 4.0 miles upstream of Fresno Road, and extends downstream for 16.5 miles to Highway 59. Only 12.0 miles could be inspected due to limited access. The views of the channel are primarily at road crossings. The photos on the following pages are typical of, but do not show all the growth in the channel. A clearing program should be implemented from Fresno Road to Healy Road.

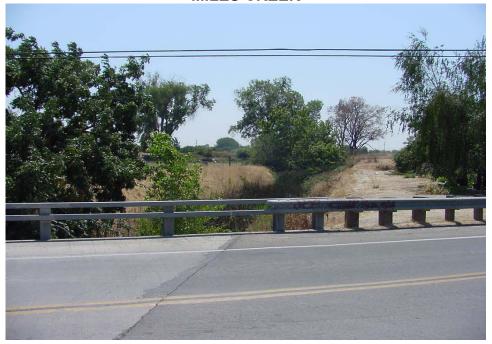
Downstream from Childs Avenue.

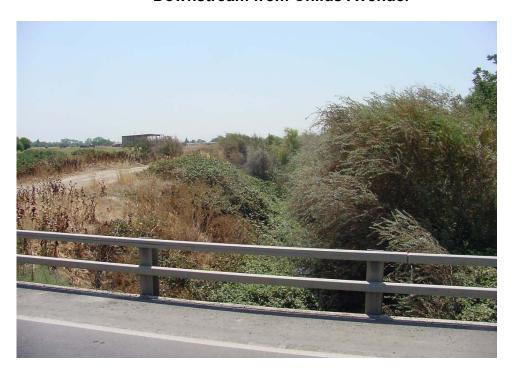
Downstream from Santa Fe Drive.

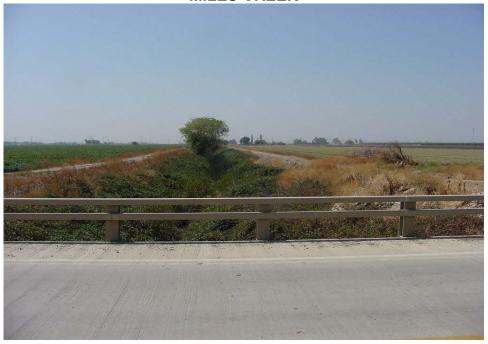
Downstream from Arboleda Drive. Blackberry need to be cleared.

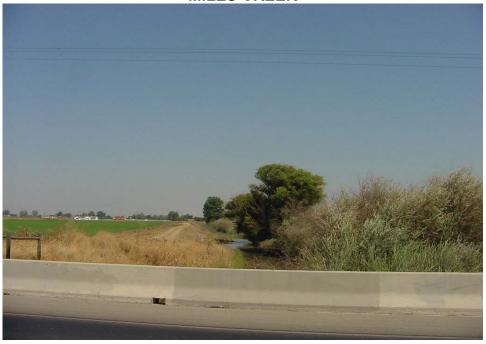
Upstream from Highway 59.The channel is overgrown with wild growth.

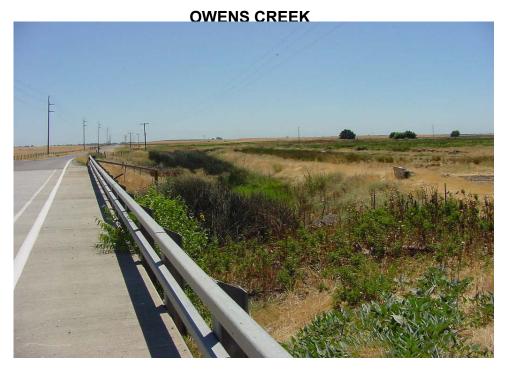
In September 2002, an inspection was made of Owens Creek channel. The project channel begins at Cunningham Road and extends downstream for 2.0 miles to Owens Creek Diversion channel. The entire channel was inspected. Only minor tule growth was found in the channel. A clearing program should be implemented.

Downstream from Cunningham Road.

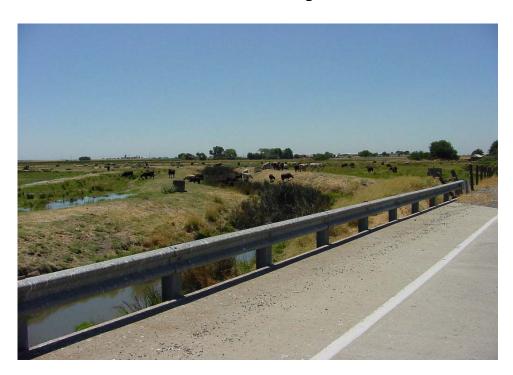
Downstream from Childs Avenue.

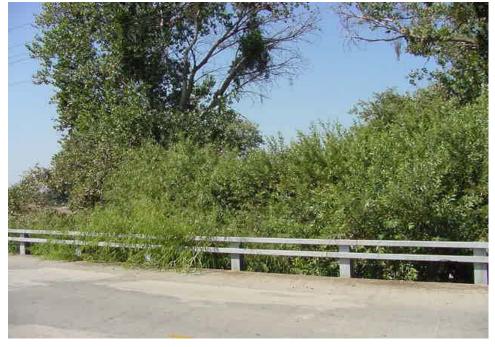
Downstream from Road 13 / Vista Avenue. Dense vegetation in channel should be cleared.

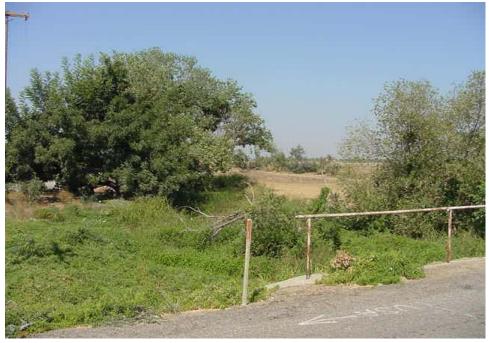
Downstream from Road 9 Bliss Road. Dense vegetation in channel.

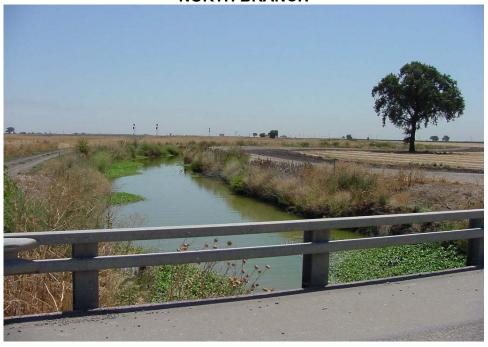
Upstream from Jack Tone Road.

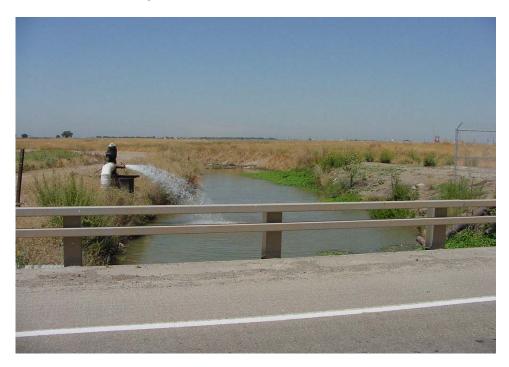
Downstream from Jack Tone Road.
